CASE STUDY: TRANSFER CHUTE RELINE MAINTENANCE IMPROVEMENT

A high-wear transfer chute was previously shut down every few weeks for liner replacement, requiring hot work and long maintenance hours. With Elastotec's Magnefast™ system, changeout time was reduced by 81% and liner life extended up to 18 months. This case study shows how this upgrade cut labour, improved safety, and boosted efficiency in their operations.

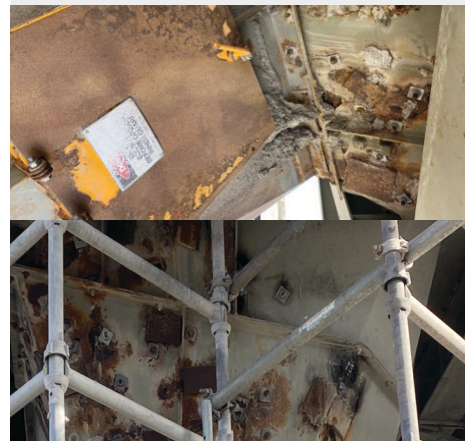
To address the site's maintenance and performance challenges, several key improvements were implemented. The chute was first laser scanned to generate accurate 3D CAD models, enabling precise redesign of the internal geometry to optimise wear paths and minimise material hang-ups.

Elastotec's Magnefast™ Ceramic Wear Liners were then installed, featuring a hot work-free magnetic attachment system that significantly simplified installation and future maintenance. The wear panel layout was carefully mapped for maximum efficiency, allowing for easy removal and replacement. Prior to installation, the chute received a new mild steel reskin with an anti-corrosion treatment to extend the overall service life of the structure.

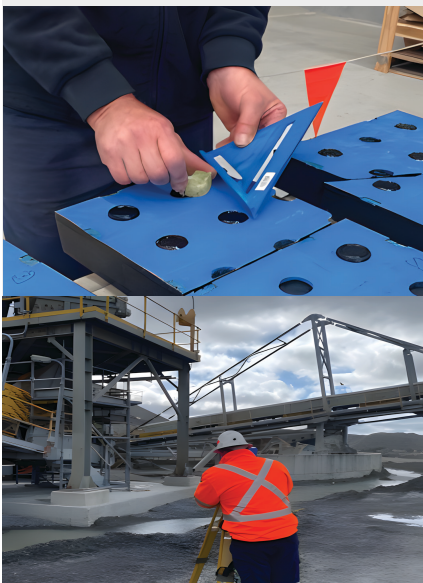
The innovative magnetic attachment system reduced liner replacement time from 22 hours to just 4 hours - an 80% improvement - while also cutting labour requirements by 80%, leading to significant savings in shutdown costs. By eliminating the need for hot work, Magnefast™ enhanced safety and removed the risks associated with confined space welding.

After three months in operation, the Magnefast™ liners required no maintenance in high-wear areas and delivered an impressive 18-month service life. In lower-wear zones, the system is projected to last over 60 months.

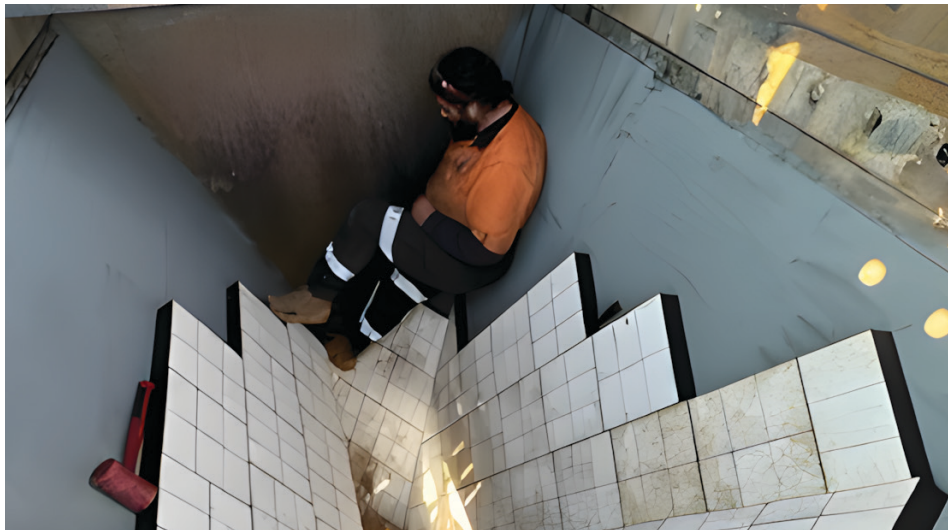
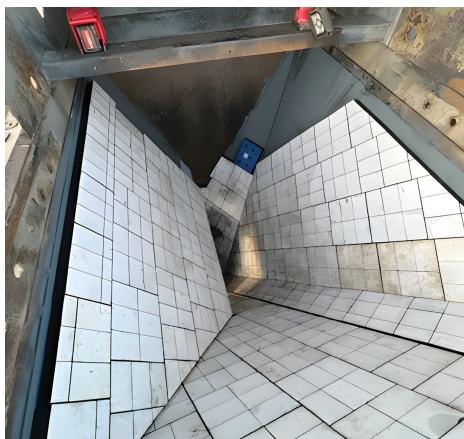
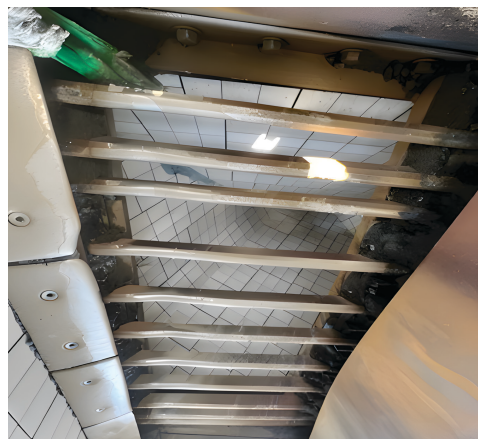
The introduction of Elastotec's Magnefast™ Ceramic Wear Liners delivered transformative results for the site.
