Curragh coal mine – improved service life of conveyor pulleys

CURRAGH COAL MINE – IMPROVED SERVICE LIFE OF CONVEYOR PULLEYS

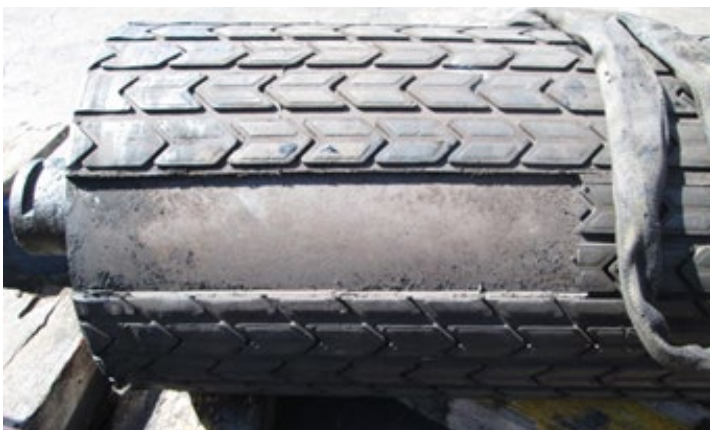
problems such as lagging debonding from the pulley shell, ceramic tiles debonding and coming out of the lagging, and edge lifting of lagging. On inspection of over 50 pulleys held on site as spares, John Herman the Business Development Manager for HEME noted that all pulleys were fitted with cold vulcanised lagging.

Lagging debonding

In response to the request from Curragh HEME consulted with Elastotec and as a result recommended a change to Hot Vulcanised (HV) FRAS Rubber and Hot Vulcanised Ceramic pulley lagging (HVCL). This recommendation was based on the fact that the HV lagging would eliminate three of the most common failure modes that the mine was experiencing:

- debonding from the pulley shell
- edge lifting
- separation and lifting at the joints between lagging strips

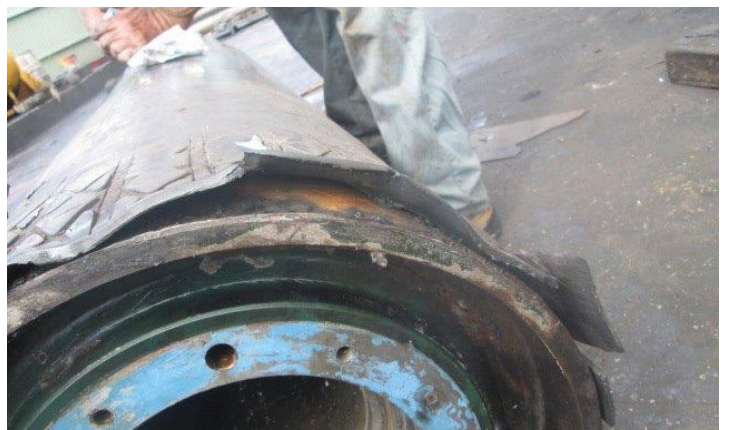
Lagging edge lifting

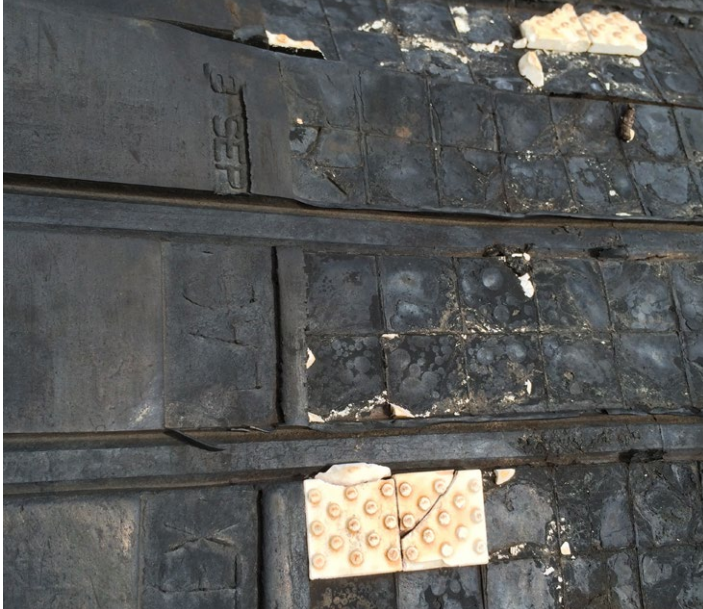
Ceramic tile loss due to debonding

Additionally Elastotec provided a guarantee that there would be no debonding of tiles from the HVCL.

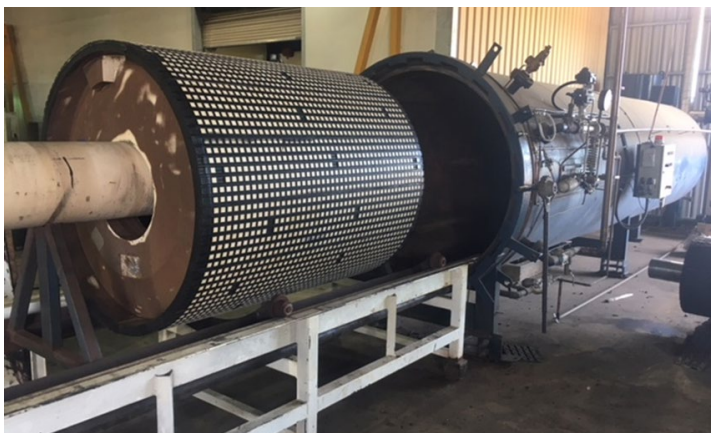
A pulley with Elastotec HVCL being removed from the autoclave

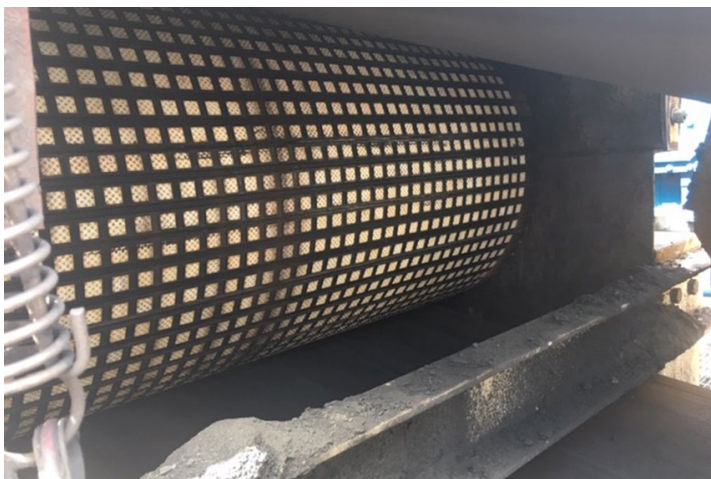
Elastotec HV Ceramic lagging operating at Curragh – note all tiles in place – no tile debonding guaranteed by Elastotec

After six months operation the decision was made to change all lagging for refurbished pulleys to the Elastotec HV lagging.

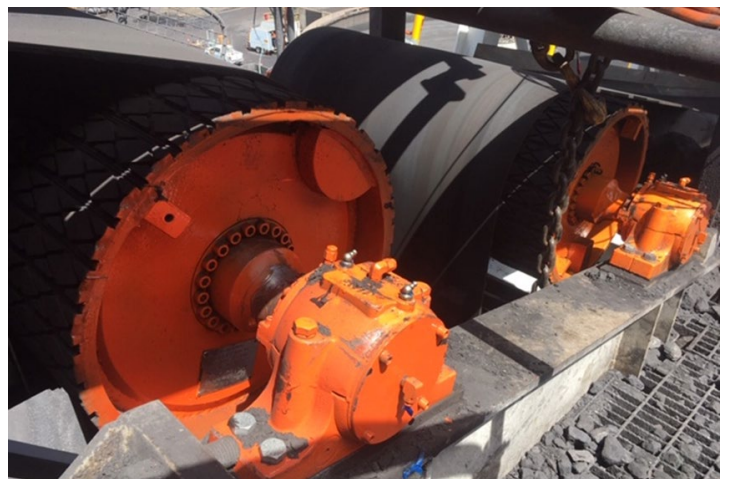
Elastotec HV FRAS Diamond Lagging Installed and operating at Curragh

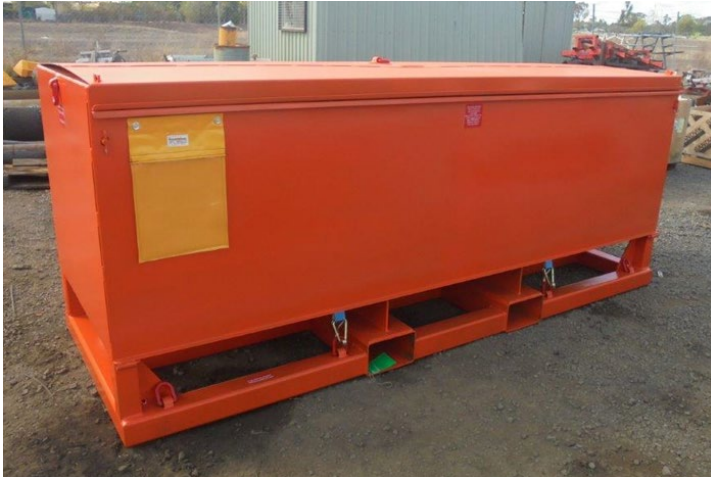
HEME pulley cradles and storage unit

To address the issue of pulley deterioration during storage HEME developed a combined pulley cradle and cover that can be used for storage either indoors or outdoors. The cover includes removable sides for inspection, external labelling and a design that allows for ventilation to prevent “sweating” in humid conditions.

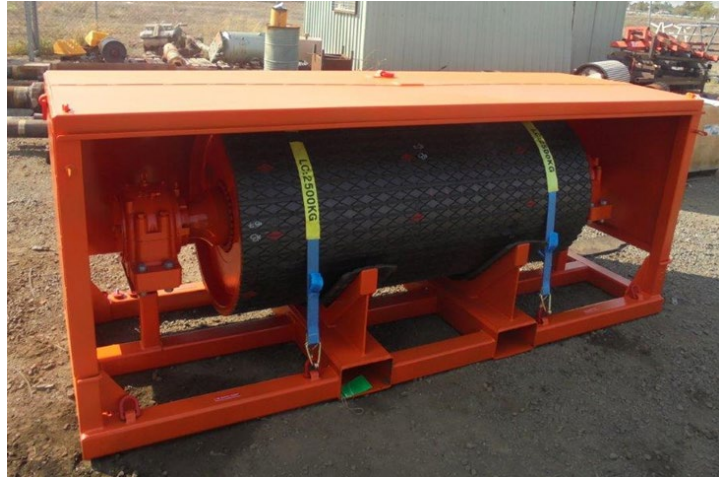
Removable sides for easy access

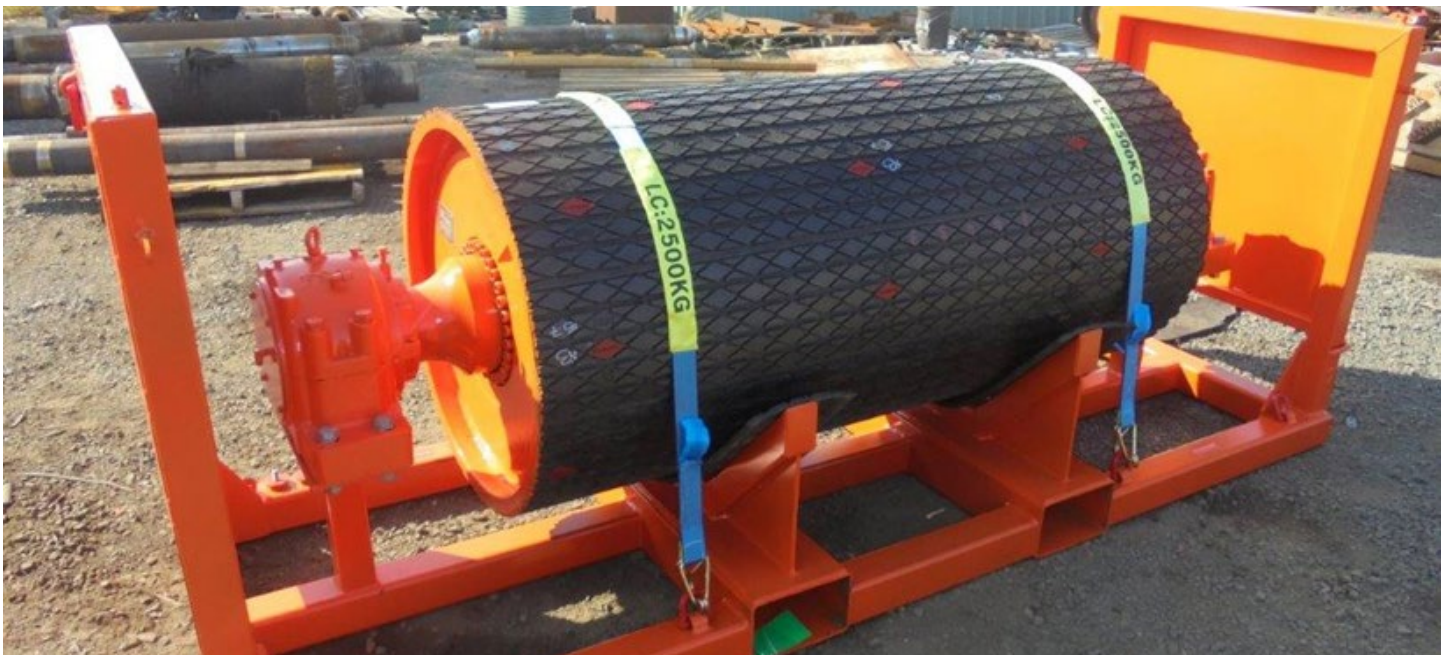
Pulley well secured in the HEME cradle – note the “RED” diamonds in the lagging that indicate “FRAS” lagging
