CASE STUDY: HOT VULCANISED CERAMIC LAGGING THE ROAD TO INCREASED CONVEYOR AVAILABILITY

A large bauxite mine in Australia, running an overland conveyor with an ST3600 belt, 1050mm wide, has successfully introduced Hot Vulcanised Ceramic Pulley Lagging to one of its sites.

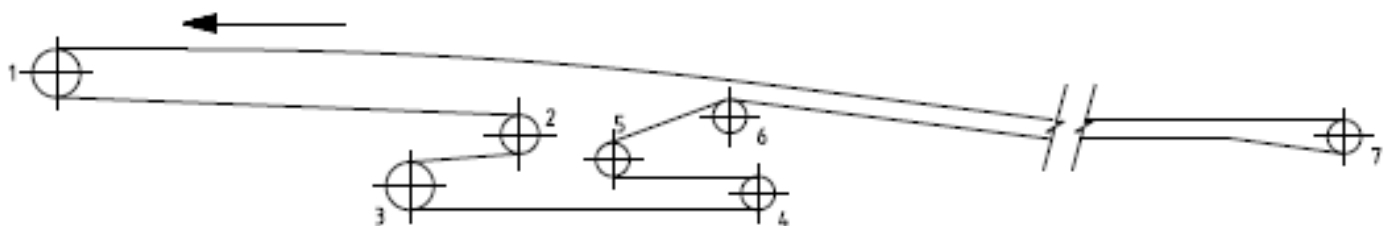
Conveyor Diagram:

However, production capacity demands mean the mining company will be upgrading from their current conveyor – 2400 tph to 3600 tph in the future. When the upgrade is complete, it will add a 2500 kw motor and increase the speed from 4.8 to 7.2m/s.

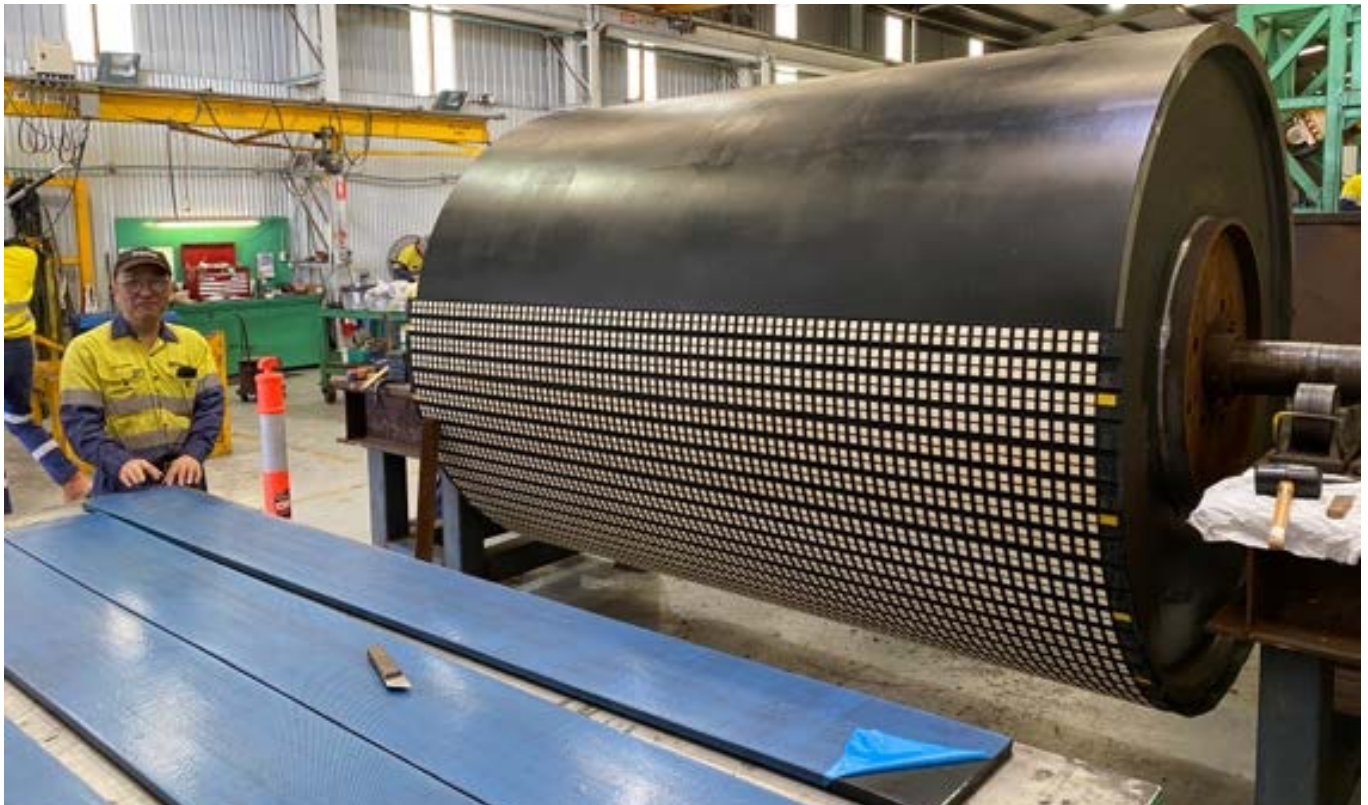
HOT VULCANISED CERAMIC LAGGING PROCESS:

- HVCL is a composite of highly abrasion resistant 95% aluminium oxide tiles bonded into a rubber backing strip. HVCL guarantees no tile debonding.
- These strips are then applied to the pulley in a hot vulcanising process where the pulley is placed into an autoclave
- The lagging is cooked onto the pulley at 140C under a pressure of 400kPa for 3 to 6 hours

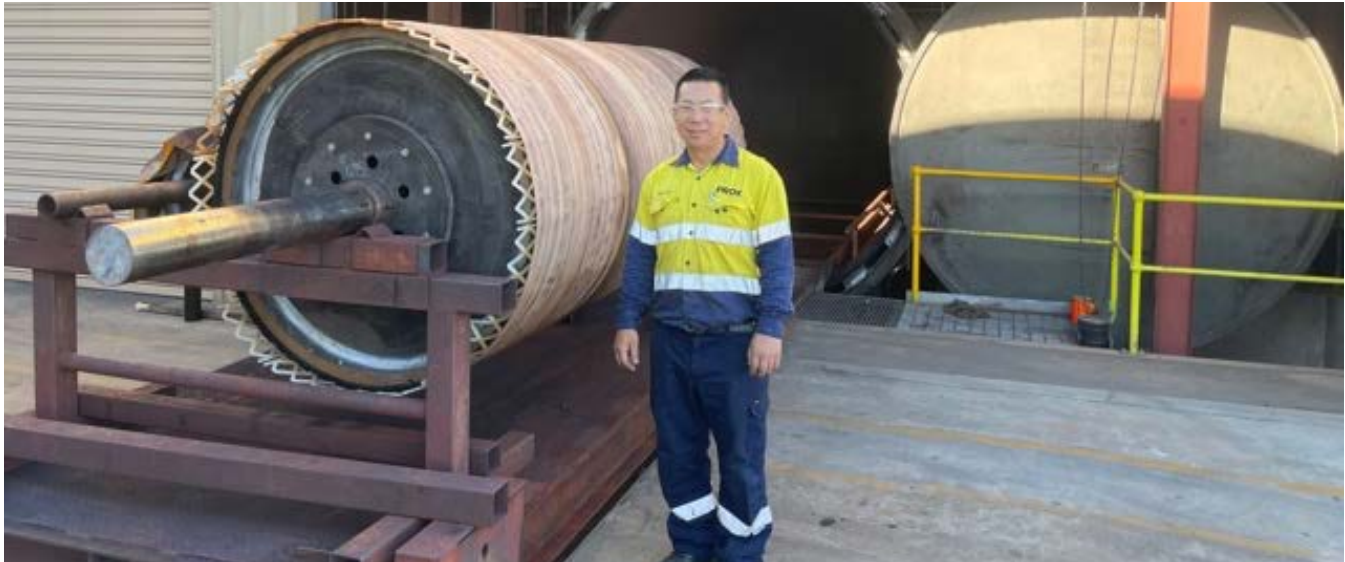
HOT VULCANISED PULLEY LAGGING INHOUSE CAPABILITIES AT PROK

The HVCL process guarantees no tile loss due to debonding, a 100% rubber tear bond to the pulley which ensures there is no chance of the lagging debonding:

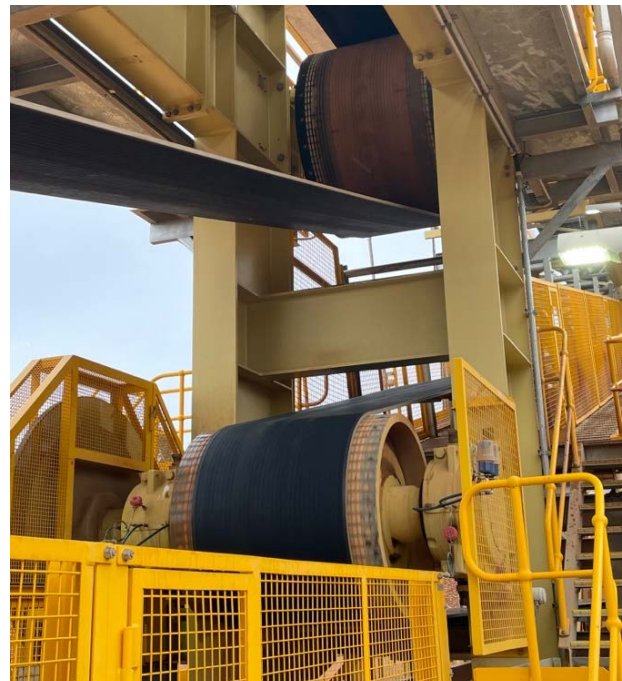
BRAKE AND BEND PULLEYS OPERATING SUCCESSFULLY WITH 12MM HOT VULCANISED CERAMIC LAGGING
