CONSEQUENCES OF CATASTROPHIC FAILURE WITH COLD BONDED LAGGING FOR NEW MINING PROJECTS

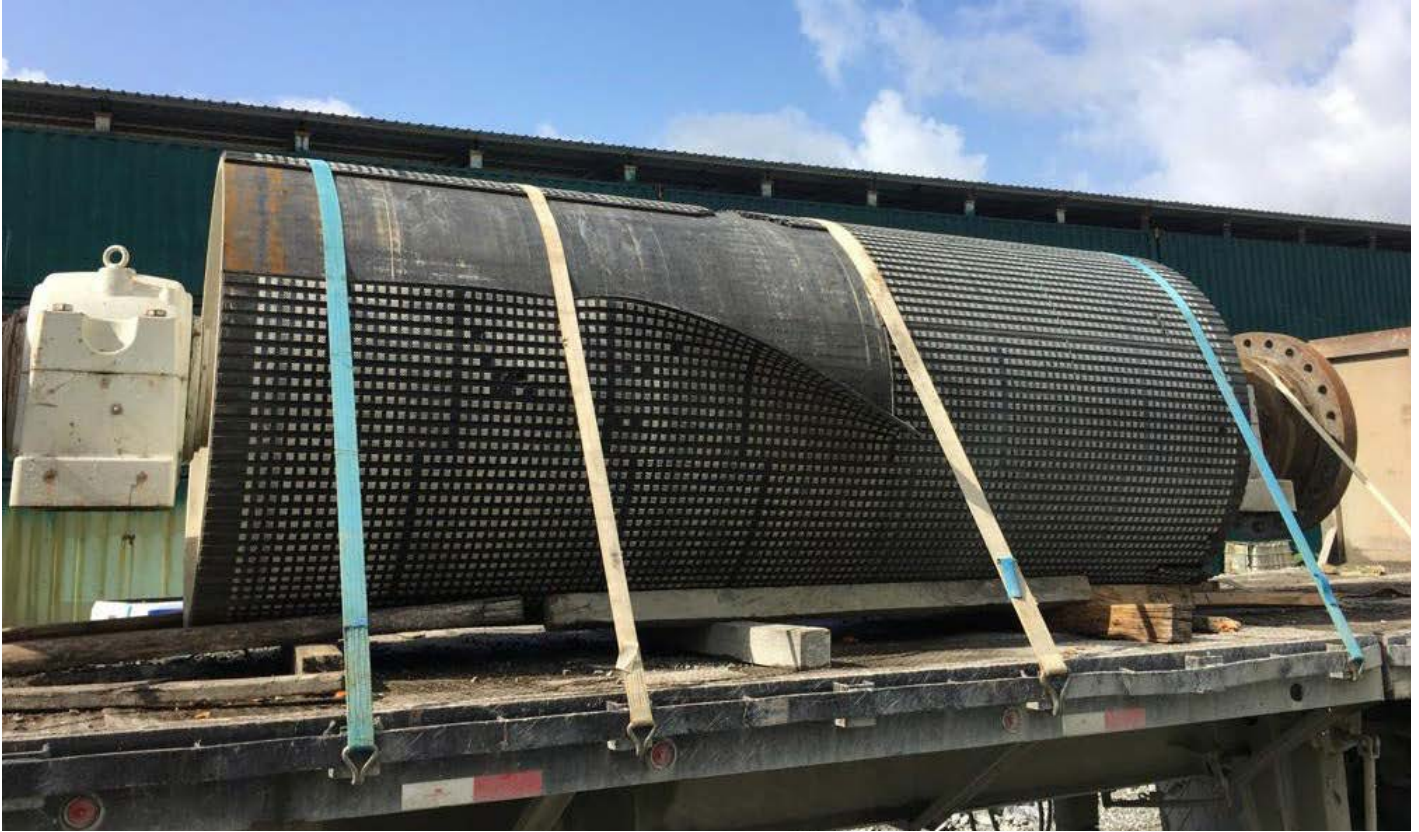
The photo above is one of four new pulleys supplied earlier this year to a new mine site undergoing commissioning and commencement of production – this was the first pulley placed into service.

Catastrophic lagging failure due to debonding occurred within two weeks of installation and operation of the pulley, resulting in a shutdown of production, and necessitated a replacement of the pulley. Within only two weeks of service, this ceramic lagging was already experiencing loss of the ceramic tiles.

The second pulley put into service as a replacement also suffered the same catastrophic lagging debonding, and resulted in a second plant shutdown. At this point, the conveyor component manufacturer PROK was contacted by the customer to evaluate and provide a solution to the failure. The pulleys in question were cold bond lagged and provided by another well-known pulley manufacturer.

PROK engaged partner supplier Elastotec to work on a solution. Our recommendation was for both new and refurbished pulleys to be applied with hot vulcanised lagging. The reason for this is that the 100% rubber tear bond achieved with a hot vulcanised lagging application, eliminates any chance of lagging failure due to debonding. In this instance, due to time pressure to restart the plant, and the lead time required to ship the pulleys for hot vulcanising, this was not an option, and the Elastotec cold bonded lagging and adhesive system was chosen.

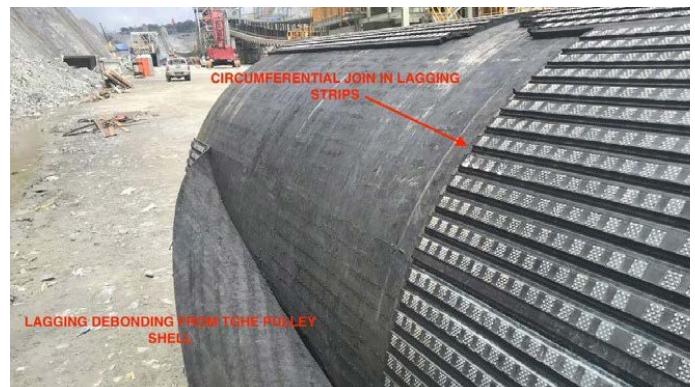
In addition to the catastrophic debonding and the tile loss after only two weeks service, a fundamental flaw in application technique was observed in a circumferential joint in the lagging (see photo below).

These pulleys have a 3600 mm face width and the original applicators have chosen to cut and join shorter strips to cover the 3600 mm pulley. This places a weak point midway across the pulley and greatly increases the risk of a lagging failure. Strippulley lagging must always be applied as strips that cover the full pulley face width in a single piece.

Elastotec supported PROK to urgently manufacture the 3800 mm long ceramic lagging strips for the four pulleys and had this shipped, with the Elastotec cold bonding system, by airfreight to the mine site. An Elastotec applications engineer was sent to the site to assist with training, and supervision of the lagging application – duplicate adhesion tests were carried out on each pulley lagged, and the results were above the Elastotec requirement of a minimum of 12N/mm. The pulleys are back online and are operating satisfactorily.

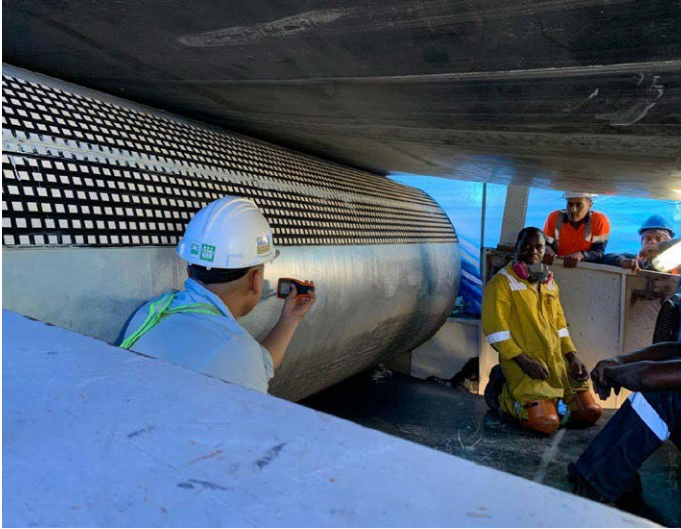
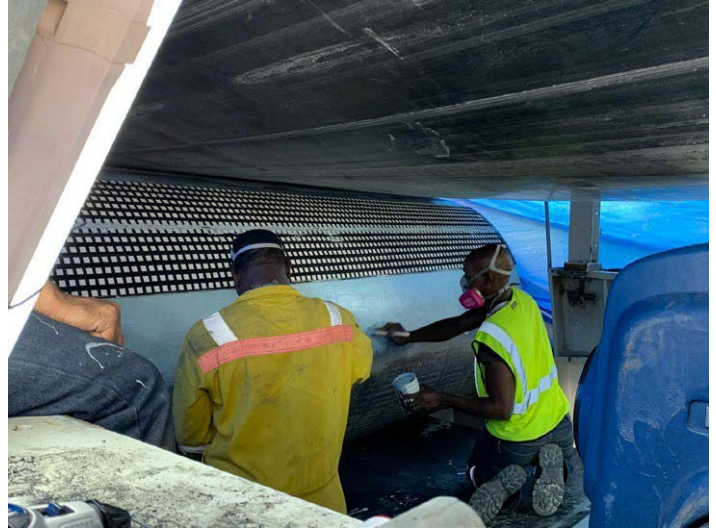
Elastotec ceramic lagging being applied on conveyor with Elastotec supervision and training
