CASE STUDY: CERAMIC WEAR PANELS FOR GOLD MINE SLURRY BOX

LOCATION: Orange, NSW
YEAR: 2021
APPLIC.: Slurry Box
SOLUTION: Bolt-On Ceramic Panels

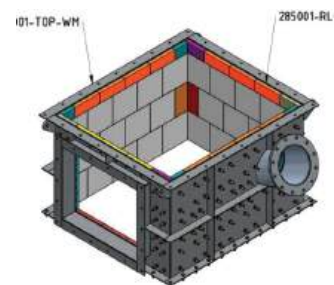
TOP SECTION

During fabrication, Elastotec utilised its state-of-the-art CNC cutting station to manufacture each wear panel to a precision tolerance of $\pm 2\text{mm}$, including accurately cut holes for 600mm, 350mm, 338mm, and 75mm pipework.

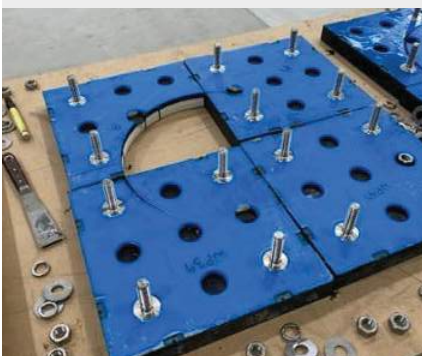
BOTTOM SECTION

Before final rubber lining and painting, a full trial fitment was conducted to verify the alignment and dimensions of every panel. This step ensured that installation on site was seamless, with all cutouts perfectly matching the incoming pipework and no modifications required during assembly.

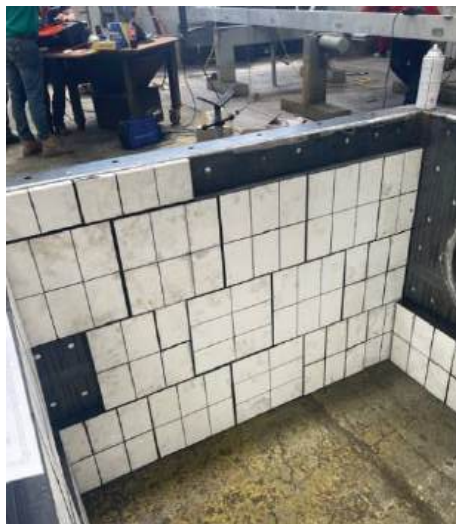
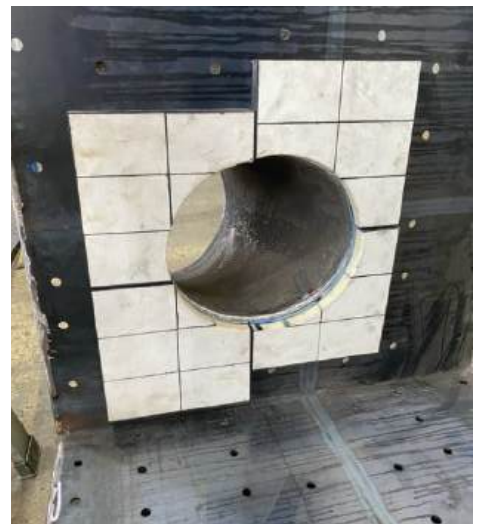
Seamless installation with zero on-site issues.

The installation achieved a perfect fit and alignment of all ceramic panels, with zero issues encountered during assembly - a direct result of Elastotec's precision fabrication and thorough pre-fit verification process.
