CASE STUDY: MAGNEFAST SYSTEM TRIAL AT IRON ORE EXPORT PORT

LOCATION: Pilbara Region, AU
YEAR: 2023
APPLIC.: Chute Lining
SOLUTION: Magnefast Wear Panels

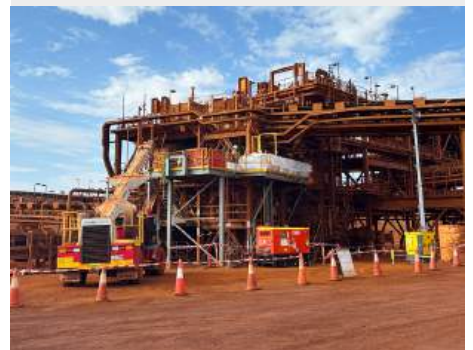
The site decided to trial the Magnefast system, a new magnetic ceramic liner technology, to address these issues - aiming to significantly reduce the time and labour involved in repairs. The installation took under one hour, compared to the usual 12-hour duration for traditional methods. The Magnefast ceramic panels were specifically chosen for their wear-resistant properties, including ZTA panels for high-impact zones.

Site personnel collaborated with the Magnefast team to design a custom wear panel layout for the chutes, incorporating a steel skin for the loading boot section and a composite wear panel map. The installation process was closely supervised to ensure optimal results.

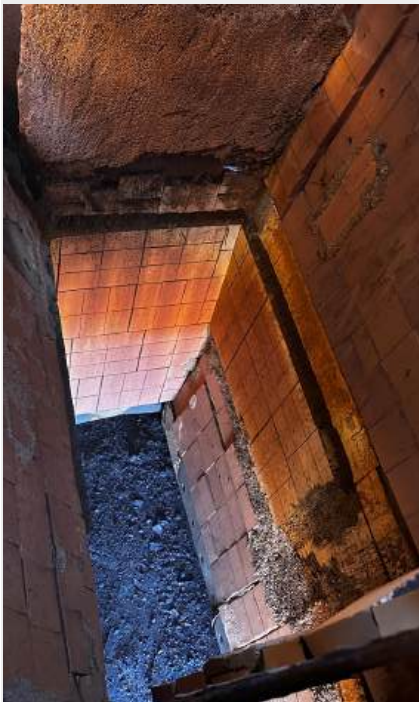
Surface ID "Z" still visible after 52 weeks service

At the 14-week shut, the results of the trial far exceeded expectations. All Magnefast ceramic liners remained in place with no movement, and there were no visible signs of wear on the ceramic panels. Notably, the ZTA wear liners, positioned in high-impact areas, still showed no signs of wear, with their "Z" markings clearly visible.

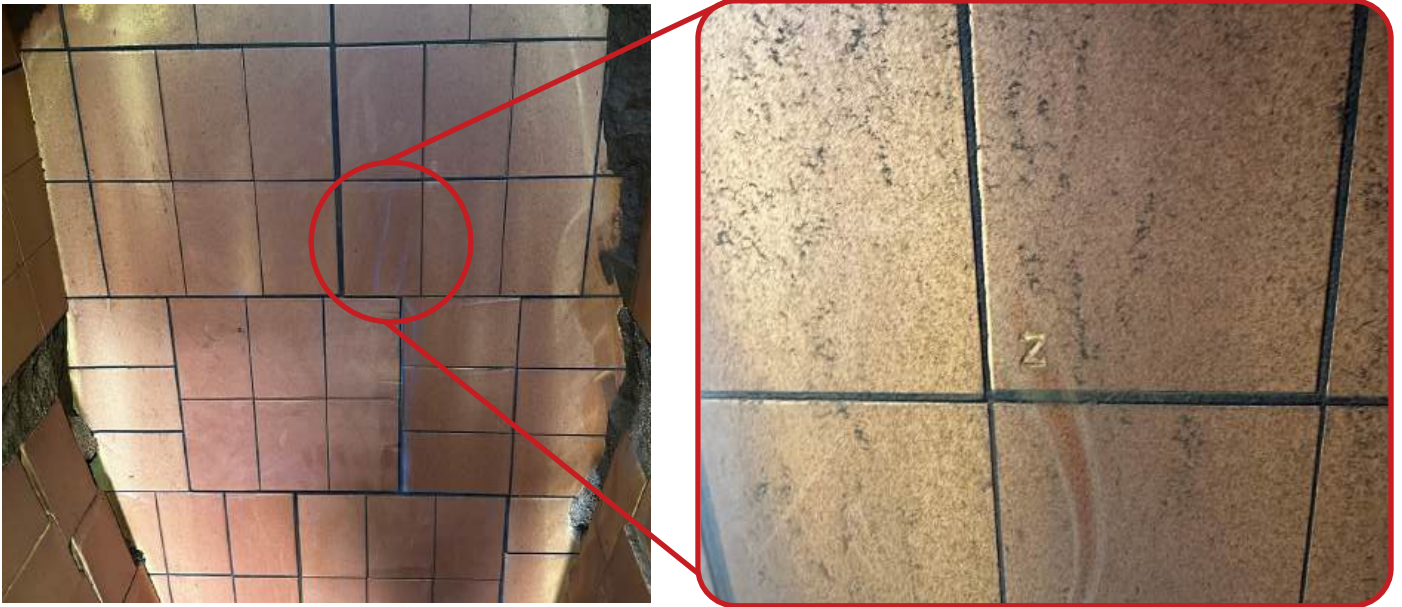
SUCCESSFUL TRIAL OF SF45/45 MAGNEFAST LINER

The parent metal showed **no signs of corrosion**

This chute is expected to **last up to 8 years in service!**

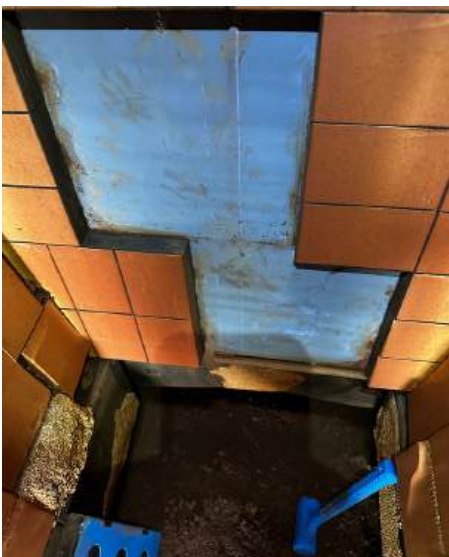
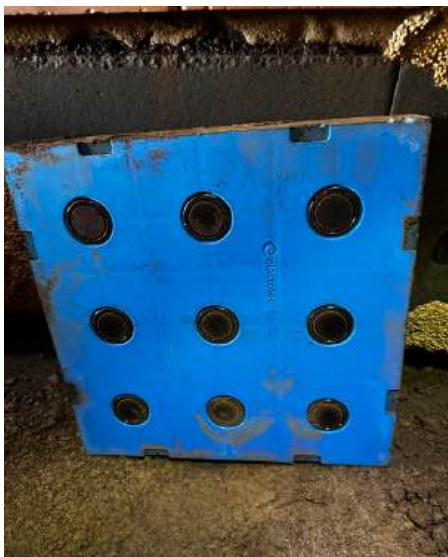
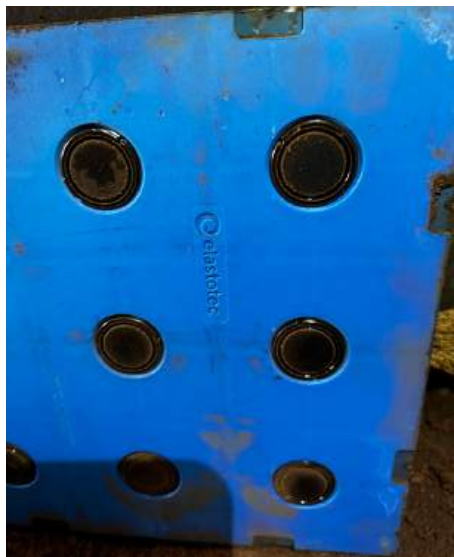
Magnefast™ magnet holding force and appearance – **no change after 52 weeks of service.**
