## CASE STUDY: SCREEN CHUTE UNDERPAN BOTTLENECK RESOLUTION

**APPLIC.:** Screen Chute Underpan

**SOLUTION:** Magnefast

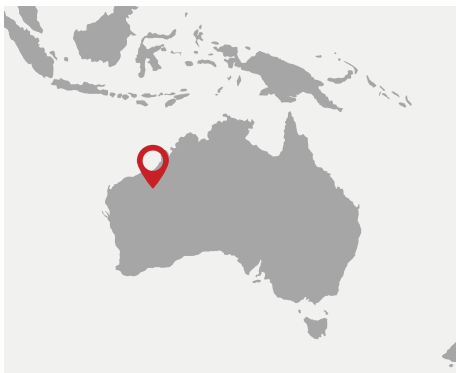
Our client, one of the largest fixed plant iron or mines in the Pilbara, was experiencing extreme bottlenecks on three screen chute underpans due to material hang up from sticky feed ore. The ore was caking onto both sides of the bisalloy parent metal.

This resulted in productivity loss and increased maintenance on all three underpans due to extensive build-up. From a reliability perspective this directly affected the feed presentation between the screen above and the conveyor below causing a host of conveyor related issues from spillage, to uneven wear.

The client engaged TSG to permanently resolve the ongoing bottleneck by introducing Elastotec's Magnefast magnetic wear panels - a next generation technology for lining transfer chutes and other bulk material inlets.

TSG scoped out the chute to understand the client's unique requirements and developed a wear panel map that outlined the quantity of Magnefast panels required, along with stop bar positioning.

A subcontractor on site erected internal scaffolding and then sand blasted each wall back to parent metal to ensure optimal adhesion.

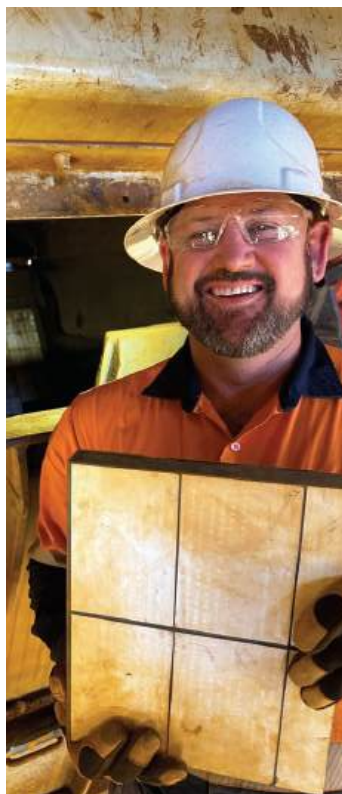
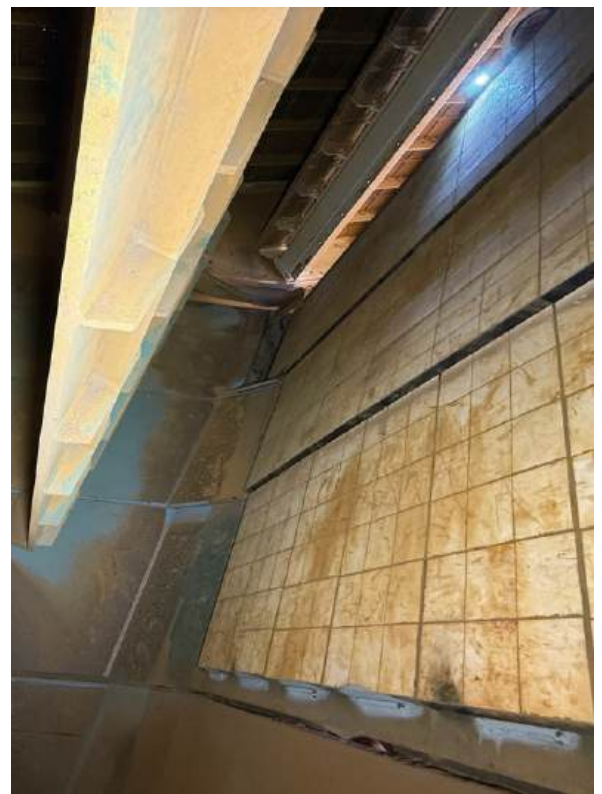
The upgraded chute system has transformed performance at the site. With Magnefast in place, the underpans now operate as a true "set and forget" solution – no longer requiring regular cleaning or maintenance.

Material build-up and hang-up have been completely eliminated, significantly improving feed flow and conveyor reliability. Maintenance demands have dropped sharply, productivity has increased, and the plant now benefits from more consistent feed presentation and reduced downtime.

The TSG service team marked out the chute and laid the Magnefast panel system from left to right ensuring all panels were level and sealed against each other.

The TSG service team tacked and then welded into place all stop bars required.
