## CASE STUDY: OYU TOLGOI HIGH TENSION BEND PULLEYS

Oyu Tolgoi is a large copper mine that has both open cut and underground operations that has been operating since 2013. The mine is jointly owned by the Mongolian government and Rio Tinto and is located in the South Gobi Desert. Once fully operational the mine is expected to produce 450,000 tonnes of copper annually.

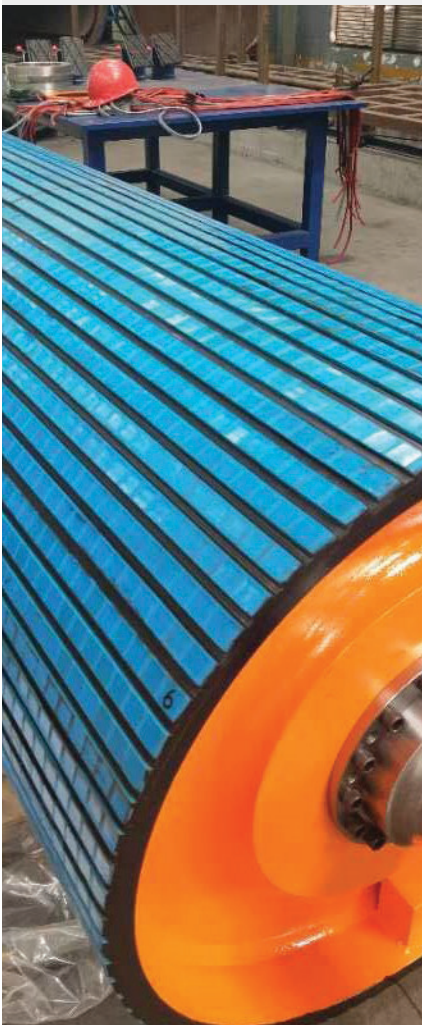
In October 2017, Elastotec applied a Hot Vulcanised Ceramic Lagging (HVCL) to two drive pulleys for Oyu Tolgoi. Both pulleys were installed in early December 2017 and were operational throughout the winter months with temperatures reaching -35 C.

Pulley performance/Lagging performance was unaffected by the low temperatures and maintenance personnel at Oyu Tolgoi indicated they were very happy with this outcome.

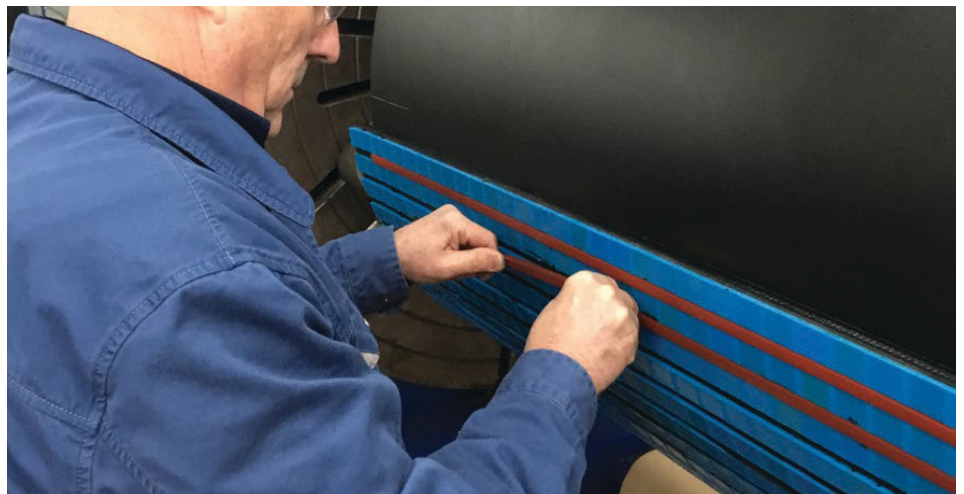
This installation has established a state of the art pulley manufacturing plant in Oyu Tolgoi and have invested in a PLC operated autoclave for applying hot vulcanised lagging. This state of the art equipment allows our partner to control both the quality of the lagging application and the lead time.

The two high tension bend pulleys with Elastotec HVPU were supplied to Oyu Tolgoi and put into service in early 2018.
