CASE STUDY: IMPROVED WEAR PROTECTION ON LARGE VENTILATION FANS IN UNDERGROUND MINING

An underground hard-rock mining operation was experiencing rapid and recurring wear on large ventilation fan impellers, resulting in frequent removals, high maintenance costs, and elevated safety risks. Elastotec, working alongside Carters Engineering, implemented a flexible ceramic wear protection solution that dramatically extended impeller service life and significantly reduced maintenance intervention.

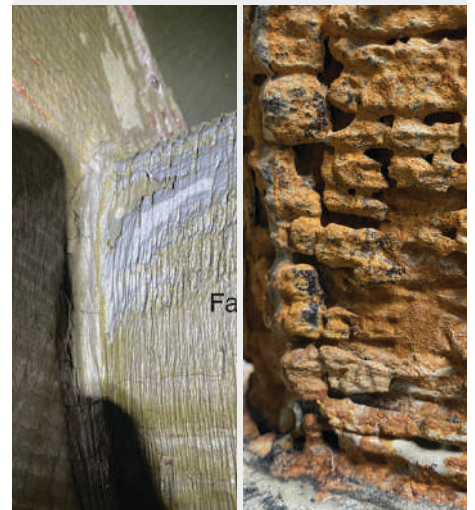
Elastotec proposed the application of flexible, light-duty ceramic tiles bonded to the leading edges of the impeller vanes using the same high-strength epoxy system employed in Elastotec's Direct Bond Ceramic Lagging solutions.

- Ⓢ Flexible ceramic tiles capable of conforming to complex curved impeller profiles
- Ⓢ High-strength epoxy adhesive with bond strengths exceeding 25 MPa
- Ⓢ Independent engineering analysis by Conveyor Dynamics confirming a safety factor greater than 10:1 under centrifugal loading
- Ⓢ CAD-designed ceramic tile layout reviewed with site maintenance personnel prior to full installation

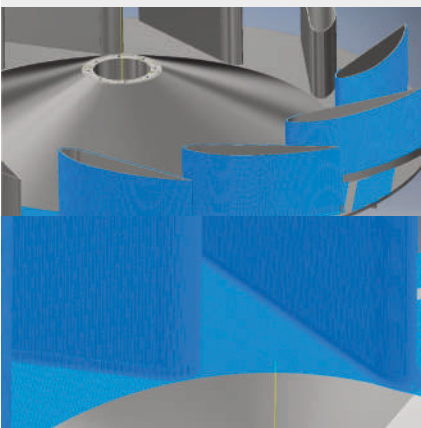
A full impeller was lined with ceramic tiles and returned to service, with performance monitored during planned maintenance shutdowns.

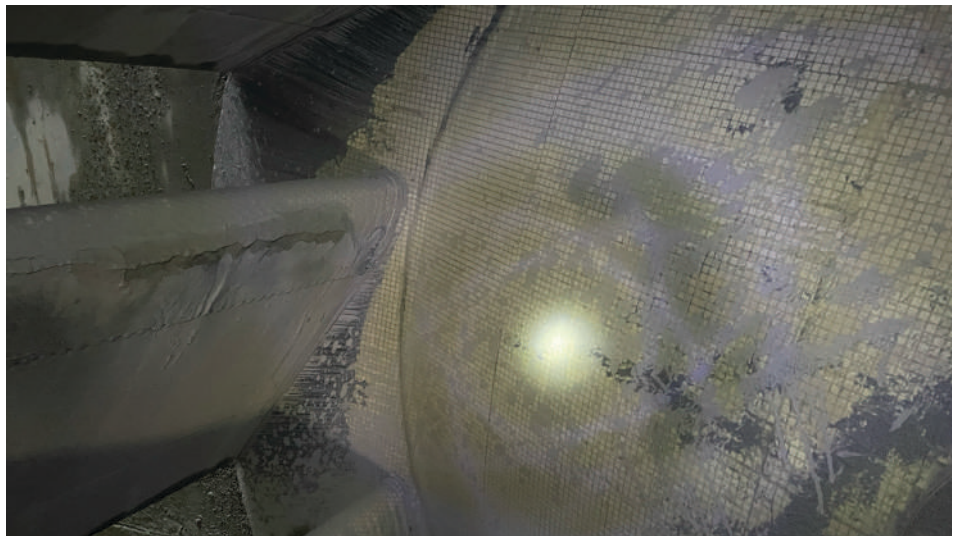
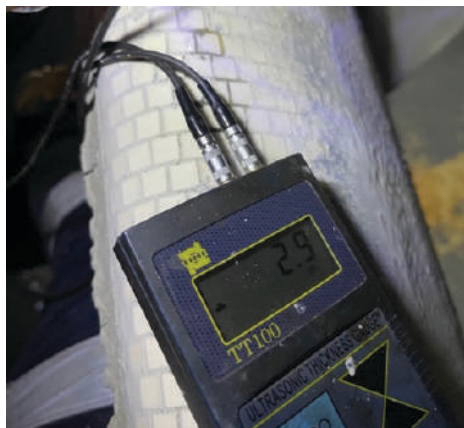
During scheduled three-month maintenance inspections, tile thickness measurements showed minimal wear from the original 3 mm ceramic thickness. The ceramic protection performed consistently under high-speed, abrasive conditions.

The improved wear protection extended the operational service life of the fan impellers to more than 12 months. During scheduled mechanical servicing, minor maintenance such as replacing isolated tiles and re-grouting was completed without full impeller refurbishment.
