## CASE STUDY:

### PROVEN PERFORMANCE LEADS TO MAGNEFAST™ SELECTION FOR CG12

**LOCATION:** West Tasmania  
**YEAR:** 2026  
**APPLIC.:** CG12 Chute  
**SOLUTION:** Magnefast™ ZTA  
**MATERIAL:** Polymetallic Ore

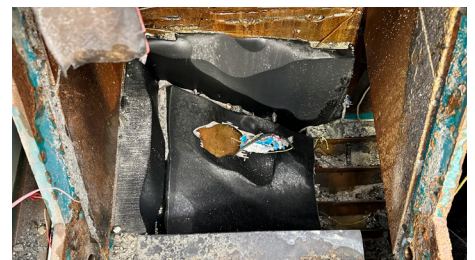
The CG12 chute's studded rubber liners required replacement every six months, creating a recurring demand for maintenance time and labour. Each changeout required resources that could otherwise be directed towards other plant maintenance priorities.

Figure 1. CG12 rubber floor liners show wear and damage after six months in service.

Magnefast™ ceramic wear liners were selected to replace the existing studded rubber liners in the CG12 chute, addressing both liner service life and the efficiency of future changeouts. The ceramic wear surface was selected to provide improved wear performance, while the magnetic attachment system eliminates the need for traditional studs, simplifying liner removal and replacement.

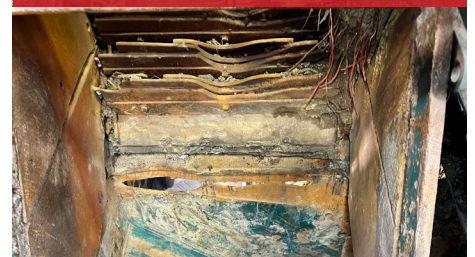
Figure 2. Wear-related holes in the CG12 chute steelwork, visible with the liners removed.

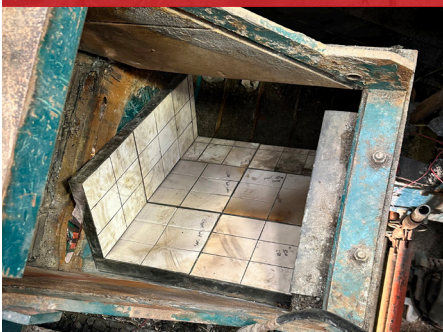
Figure 4. Magnefast™ ceramic wear liners installed on the CG12 chute floor and side wall.
